Dutch East India Company Shipbuilding

THE ARCHAEOLOGICAL STUDY OF
BATAVIA AND OTHER SEVENTEENTH-
CENTURY VOC SHIPS

Wendy van Duivenvoorde

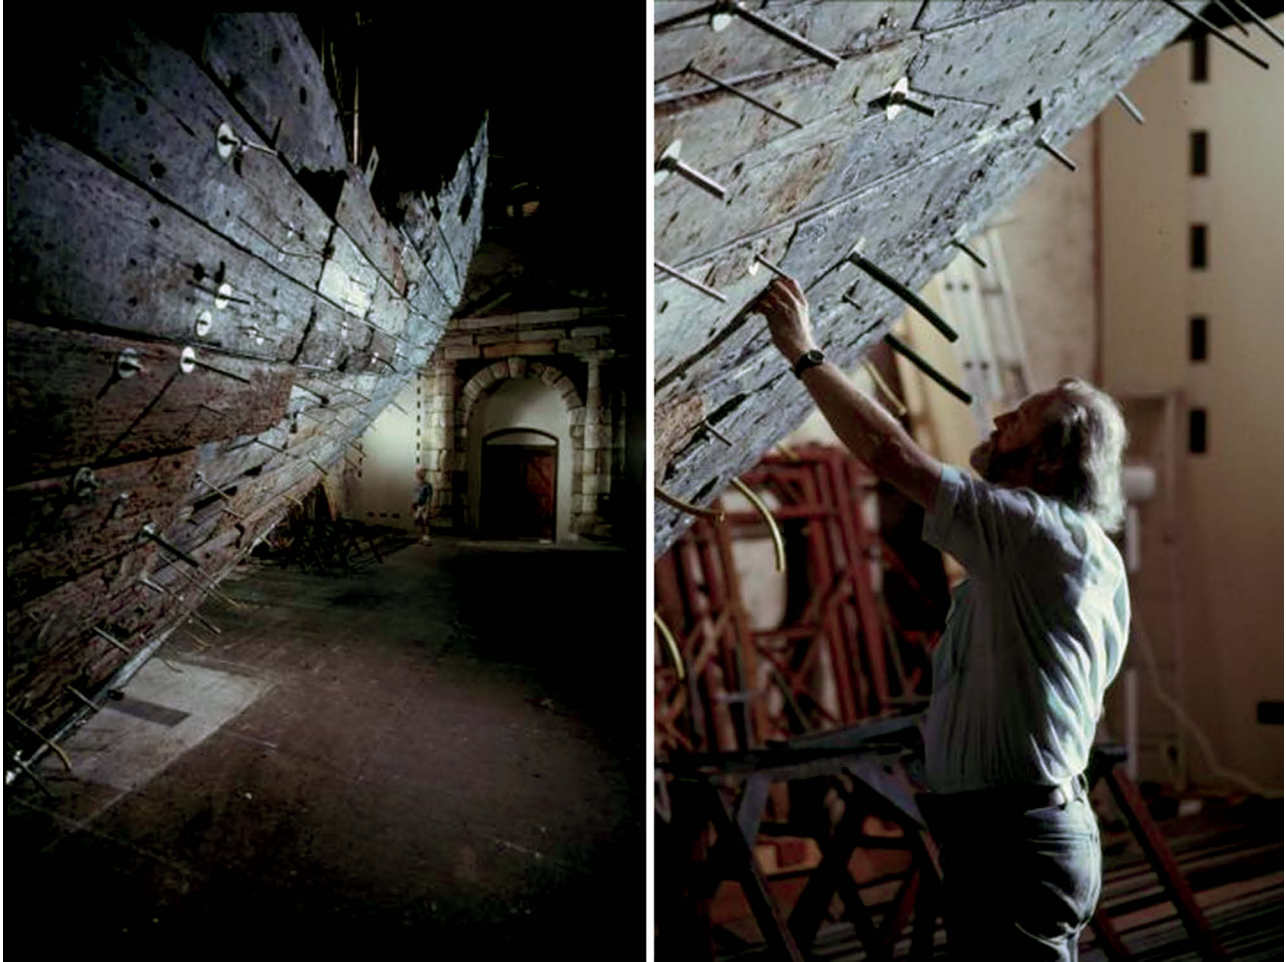
FIGURE 3-28. Galvanized 16 $\frac{3}{4}$ mm rods used as screws to hold the planks and frames together, Western Australian Museum—Shipwreck Galleries, Fremantle. Photographs by Patrick Baker, Western Australian Museum (BT-T-0414 and BT-T-0431).

needs to be taken off the display (fig. 3-27). Initially, small vertical lips were added to the edges of the battens (one on top and one on the bottom) to prevent the outer layer of hull planking from falling out. Most of them have been removed, as the 16.75 mm threaded galvanized rods, used in the reassembly to fasten the frames to the hull planking, provided sufficient strength for keeping the outer layer of hull planking in place. The galvanized rods were inserted into selected original bolt holes (fig. 3-28). They were used

as large screws with a washer and nut on either side of the timber assembly and trimmed to lie flush with the exterior surface after the entire hull was reassembled.

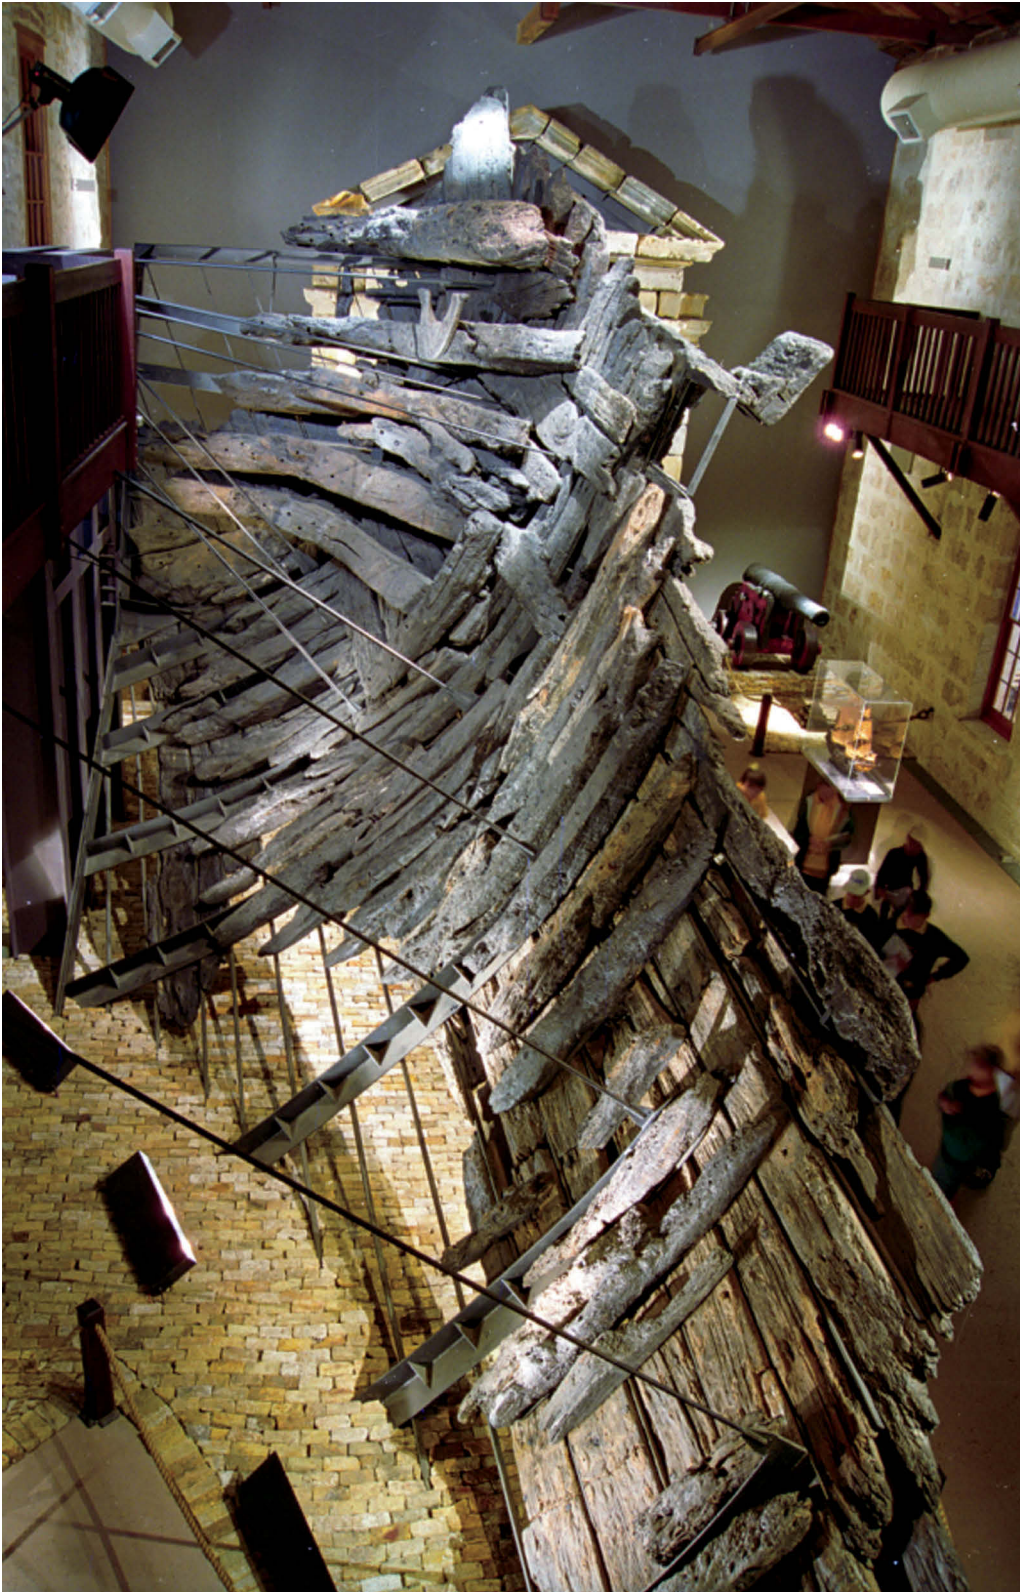
FIGURE 3-29. Interior view of *Batavia*'s hull on display, Western Australian Museum—Shipwreck Galleries, Fremantle. Photograph by Patrick Baker, Western Australian Museum (MA5049-33).

The weight of the entire framework that supports the *Batavia* hull is counterbalanced by seven diagonal steel rods run from the upper gallery balustrade and the load-bearing pillars to the side of the hull, where they are fastened to the backing plates of the frames (fig. 3-29).

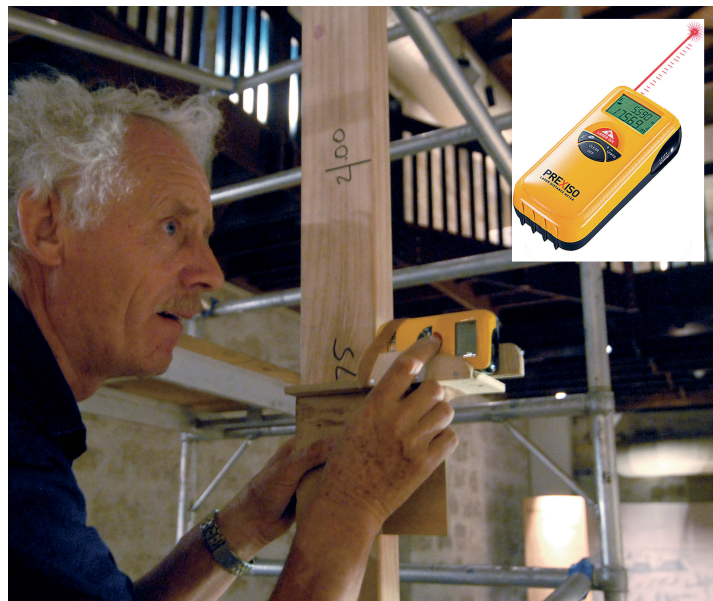
FIGURE 3-30.
Bill Leonard using the
Prexiso laser distance meter.
Photograph by Patrick Baker,
Western Australian Museum.

Maritime History Department of the Western Australian Museum.³³ Leonard brought in a Prexiso laser distance meter, which made our exercise easy and saved stretching measuring tapes in a straight line when taking offset measurements (fig. 3-30). This small handheld device measures distance quickly and efficiently within an accuracy of 3 mm. Its measuring capability ranges from a distance of 10 cm to 40 m, and it is operated with

a 9-volt block battery. The default reference setting is the base of the instrument, which had to be taken into consideration for taking the offset measurements. All Prexiso laser meter measurements were taken twice, and the deviation between the two measurements was not once greater than 2 mm.

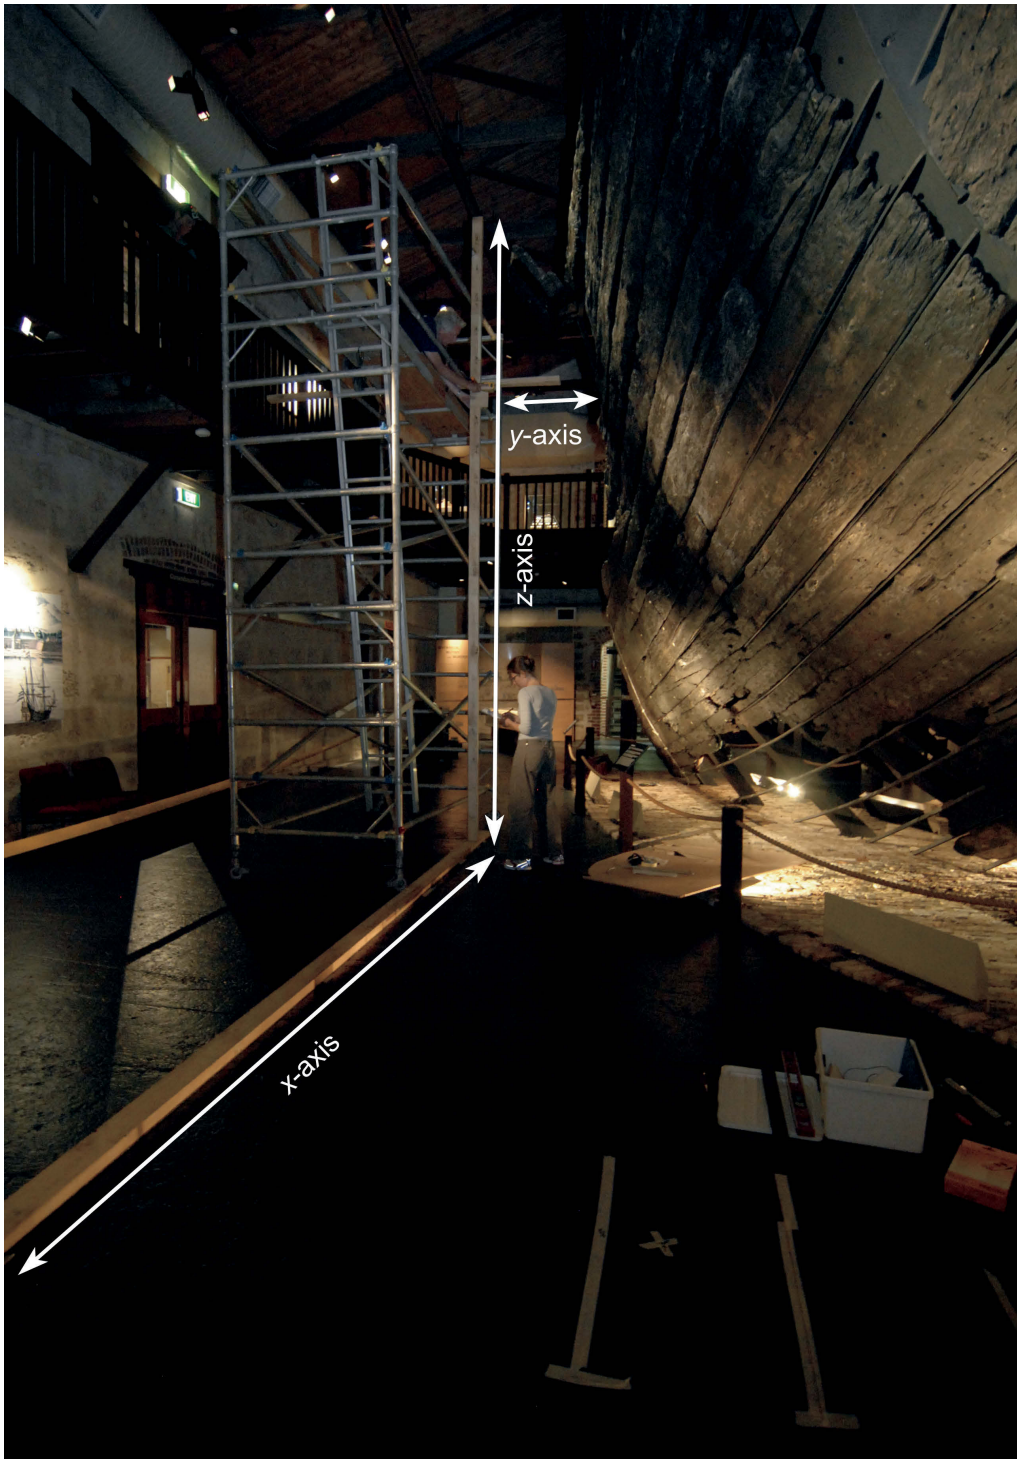
FIGURE 3-31. Measuring setup for taking curvatures off *Batavia*'s hull, showing leveled x-axis and z-axis beams for taking station lines, Western Australian Museum—Shipwreck Galleries, Fremantle. Photograph by Patrick Baker, Western Australian Museum.

Setting up the measuring system was more time-consuming than taking the actual measurement. First, two parallel baselines, 11 m in length and 5 m apart, were laid out on the gallery floor. The first baseline was stretched along the inside of the five steel pillars that support the framework of *Batavia*'s timbers. These pillars mark the port-side surface of the preserved sternpost (and, thus, that of the keel). From this baseline, the angle of the sternpost and the exact height of the 20 (Amsterdam) ft waterline mark were measured. A 5 m measuring tape was affixed perpendicular to this baseline aft of the transom (= station 0). From here, the lateral and vertical curvature of the wing transom was measured. Scaffolding was placed outside this 5 m line (x -axis) (fig. 3-31), from which a plumb bob was lowered that was held against the wing transom at 50 cm intervals along the 5 m line (x -values). The wing transom points indicated by the plumb bob were marked on a piece of white masking tape on the floor with a permanent marker. Then, the distance

between the mark on the floor and the 5 m baseline was measured with a tape measure (y -value). A large builder's angle was used to ensure a 90-degree angle between the 50 cm interval value on the x -axis and the y -values of the wing transom. From the points marked on the floor, an easy vertical measurement could be taken with the Prexiso laser distance meter from the mark on the floor to the corresponding point on the wing transom, where the plumb bob was being held. This provided a height measurement (z -value) to the wing transom.

After these measurements were completed, a second parallel baseline was measured out from the first to the exterior of the hull, which formed the baseline from which the offsets of the station lines were taken. Ten station lines were measured at intervals of 1.1 m along the second baseline (x -values). Flush against the exterior of the baseline, a stiff pine straightedge, 10 by 5 cm in cross section, was affixed on which the stations were marked (fig. 3-31). On these station marks, another vertical straightedge (z -axis) was positioned and clamped to the scaffolding that was set up behind the baseline. On this straightedge the vertical offset measurements (waterlines) were marked at an interval of 25 cm from the baseline up (fig. 3-32). This straightedge was accurately leveled plumb in both vertical directions with a spirit level to ensure a 90-degree angle between the x - and z -values. Also, great care was taken to align the interior surface of the baseline straightedge flush with the interior surface of the z -axis straightedge to minimize any measurement errors. Subsequently, the Prexiso laser distance meter was placed perpendicular to the z -axis straightedge in a custom-made wooden case to ensure it measured square to the hull in the xy -axis (see fig. 3-30). It also guaranteed that the back of the distance meter, from where the measurements are taken, was seated flush against the interior surface of the z -axis straightedge. The box with the distance meter could be moved up the straightedge to each 25 cm waterline marker to take a y -value measurement to the ship's hull. Each measurement was taken twice to ensure accuracy and to double-check the distance readings.

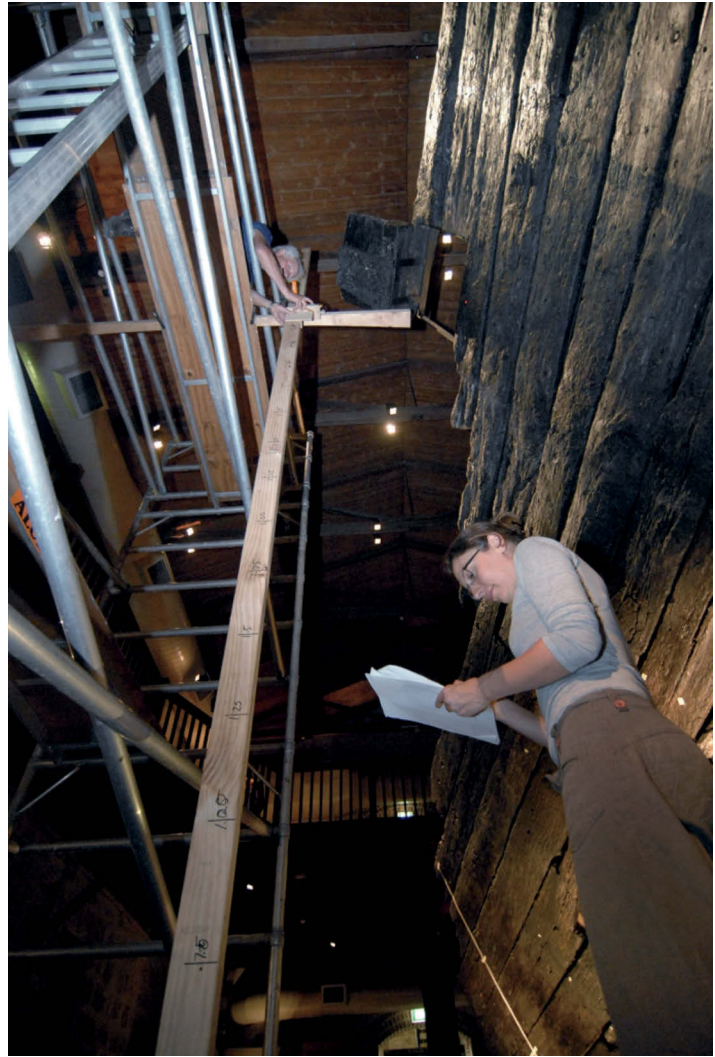
FIGURE 3-32.
 Bill Leonard (*top left*) and the author (*lower right*) taking a distance measurement from the z-axis beam to the hull, from a height of 3.75 m, Western Australian Museum—Shipwreck Galleries, Fremantle. Photograph by Patrick Baker, Western Australian Museum.

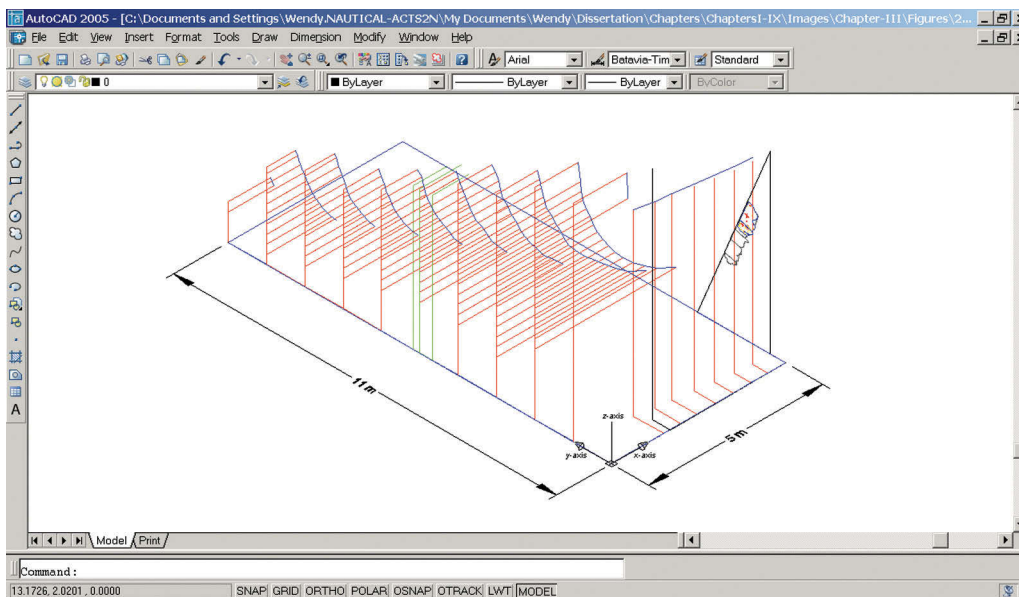
FIGURE 3-33. Screenshot of measurements of *Batavia*'s hull lines entered into AutoCAD 2005 program.

In the evenings, all measurements taken during the day were entered and plotted in AutoCAD so they could be redone the next day if errors or other problems occurred (fig. 3-33). It must be noted that all measurements were taken to the outside of the hull. Furthermore, some measurements of the four aftermost stations were taken in places where the outer layer of hull planking is no longer present. In this case, an adjustment needed to be made to correct the difference in planking thickness. Overall, this method has proven to be an efficient and accurate means to take lines of *Batavia*'s after port side and transom.

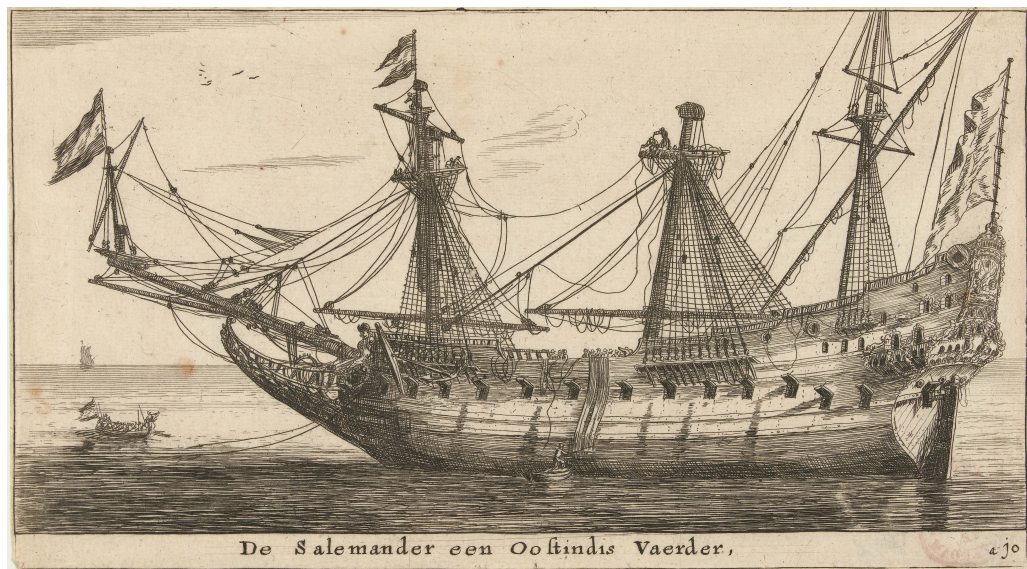
FIGURE 4-3.
Dutch East Indiaman
Salamander, partially
unrigged, built in 1639
by the VOC Chamber of
Amsterdam. Engraving
by Reinier Nooms,
1652–54, Rijksmuseum
Amsterdam (RP-P-
OB-20.528).

on the engraving of the partially unrigged Dutch East Indiaman *Salamander* (1,000 tons), which was built in 1639 according to the same shipbuilding charter as *Batavia* (fig. 4-3).

The large Dutch East Indiamen *Salamander* and *Parel* (1,100 tons) were built by the Chamber of Amsterdam in 1639 and 1651, respectively.²³ Although these particular ships were much larger than *Batavia*, they had one row of gun ports along each side of the vessel, plus one gun port in the transom on either side of the sternpost (see figs. 4-3 and 4-5). *Batavia* probably had a similar arrangement with 14 of its cannon on each side of the lower gun deck and two gun ports at its transom. It would seem, then, that both publications of *The Unlucky Voyage* feature inaccurate depictions of the vessel.

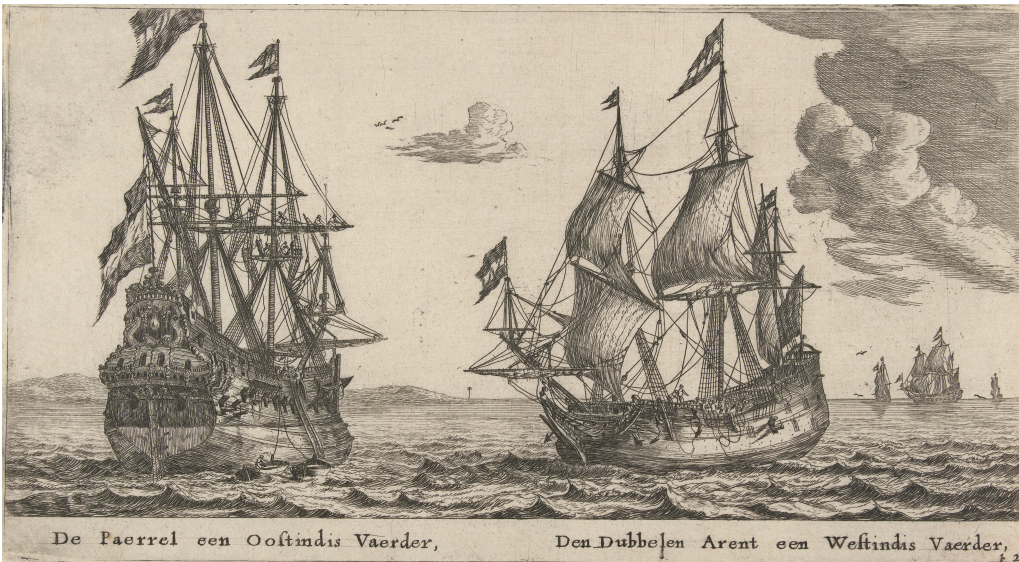
FIGURE 4-5.
Dutch East Indiaman *Parel* (left), built in 1651 by the VOC Chamber of Amsterdam, and West Indiaman *Dubbele Arent* (right). Engraving by Reinier Nooms, 1652–54, Rijksmuseum Amsterdam (RP-P-OB-20.534).

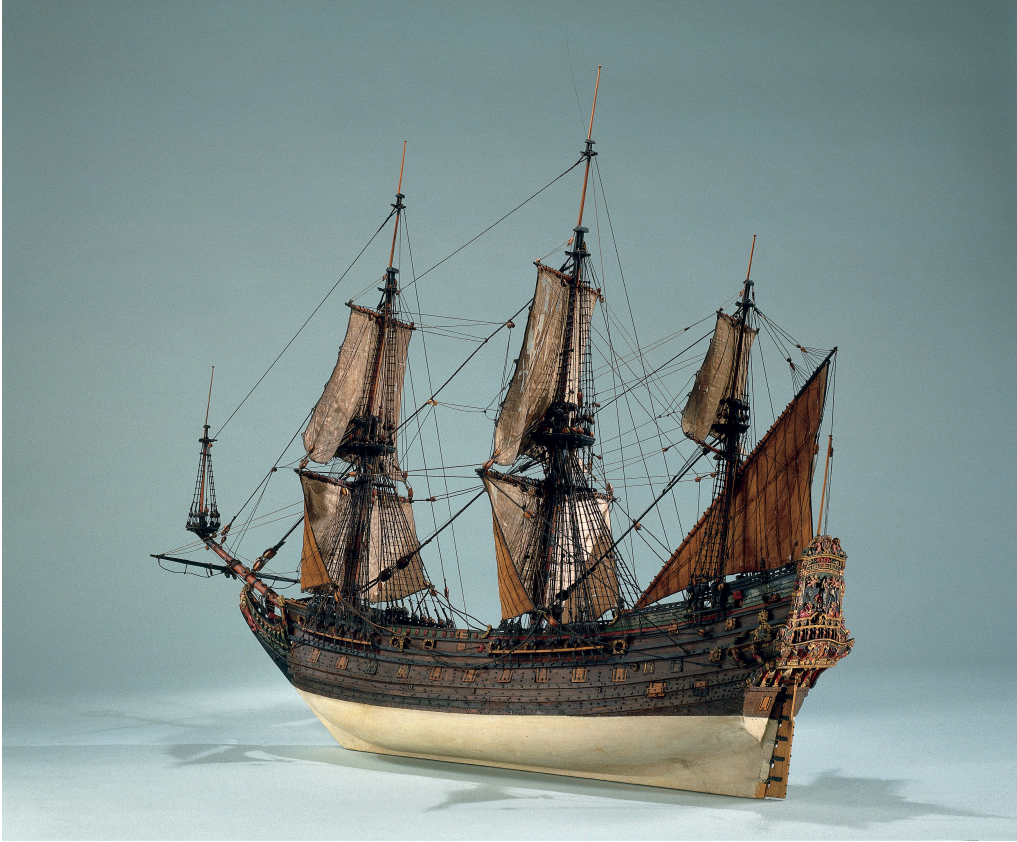
FIGURE 4-7.
Contemporary
model of Dutch
East Indiaman *Prins
Willem*. Anonymous,
1651, Rijksmuseum
Amsterdam.

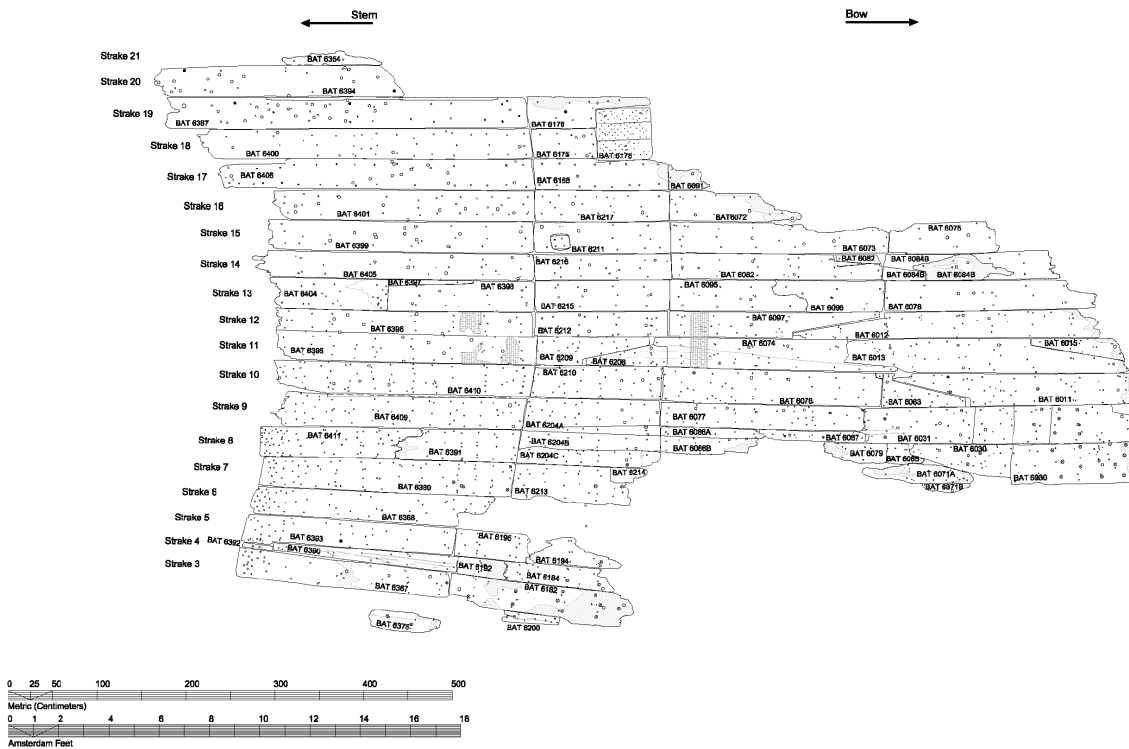
FIGURE 4-10.
Timber plan of inner
layer of hull planking,
preserved strakes
3–21, port side, interior
surface. Illustration by
author.

Batavia's lower preserved hull and its transom are double-planked up to the twelfth preserved strake, which may correspond to the ship's waterline (figs. 4-10 through 4-13). The two layers of hull planking have essentially the same thickness; each strake measures 8 to 9 cm in thickness, with an average thickness of 8.7 cm.²⁴ Thus, the maximum hull planking thickness of the ship's bottom is 18 cm (7 Amsterdam thumbs). The seams of each plank layer are offset by only a few centimeters, which is probably the result of both layers of planking being rabbeted into the keel (fig. 4-14). The maximum planking width varies from 25 cm (strake 4) to 45.1 cm (strake 7), with an average width of 33.9 cm. The longest preserved hull plank is strake 9 of the inner layer of hull planking, which measures 9.72 m (the strakes discussed in this section are illustrated in fig. 4-11).²⁵ This plank is, however, not preserved in its entirety, as the scarf at its forward end only partially survived.

Fastenings found in *Batavia* were made of wood, iron, and copper. Most of the wooden and copper fasteners are still present, whereas the majority of the iron fasteners did not survive. The inner layer of hull planking and the frame timbers of the ship's bottom were assembled by treenails driven in from the exterior and pegged in place with square tapering wooden pegs (see figs. 4-19 and 4-20). These treenails were probably also wedged on their interior, although no evidence of this practice has been found to date. The treenails have an average diameter of 32 mm, although they tend to be 1 or 2 mm larger in diameter on the planking's external face than on the interior. Treenail pegs vary in width from 1.5 to 2 cm in width and taper to a point. Generally, three treenails were inserted in a staggered pattern along each plank. This fastening pattern can be seen clearly on inner hull planks BAT 6030, 6031, and 6192 (see fig. 4-10).

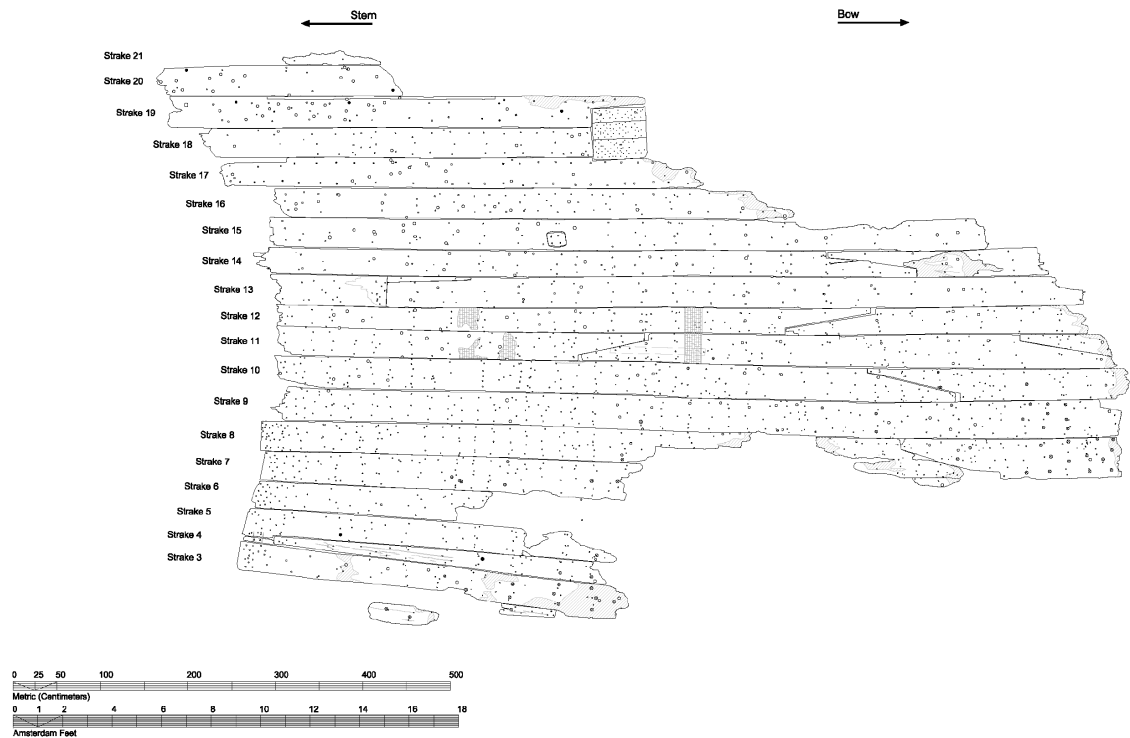
FIGURE 4-11.

Reconstruction plan of inner layer of hull planking, preserved strakes 3–21, port side, interior surface. Illustration by author.

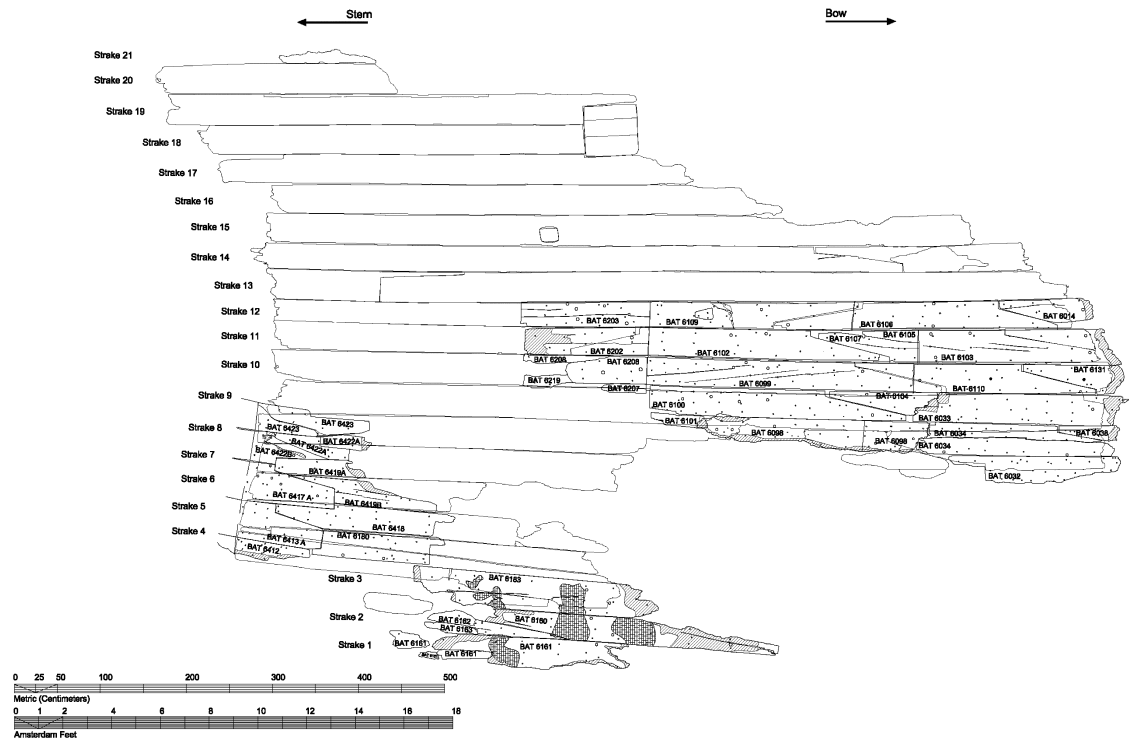
FIGURE 4-12.

Timber plan of outer layer of hull planking, preserved strakes 1–12, port side, interior surface. The inner layer of hull planking is outlined in gray in the background for orientation. Illustration by author.

mostly worn away on strakes 8–15 aft of the gun port, although the hull was sheathed up to the fifteenth strake (see figs. 4-12 and 4-13). The exterior layer of planking has been preserved relatively well for about 2 m directly forward of the transom from strakes 3 to 8, and about 4.5 m from strakes 1 to 3.

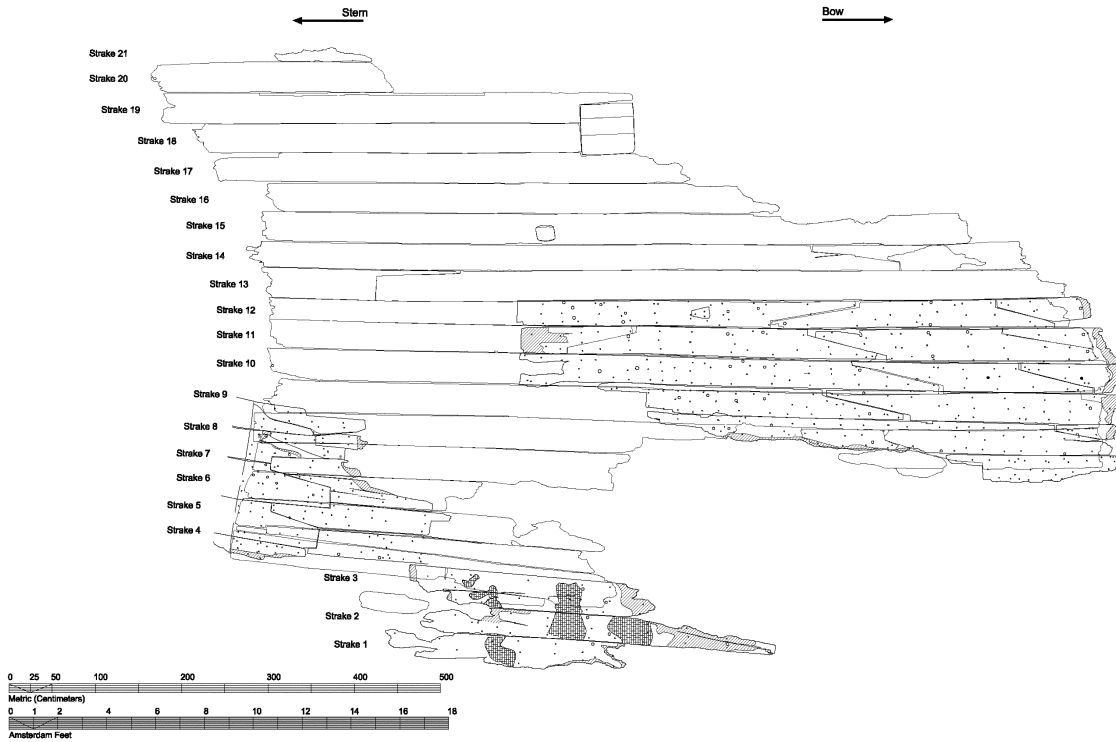
FIGURE 4-13.
Reconstruction plan
of outer layer of hull
planking, preserved
strakes 1–12, port side,
interior surface. The
inner layer of hull
planking is outlined in
gray in the background
for orientation.
Illustration by author.

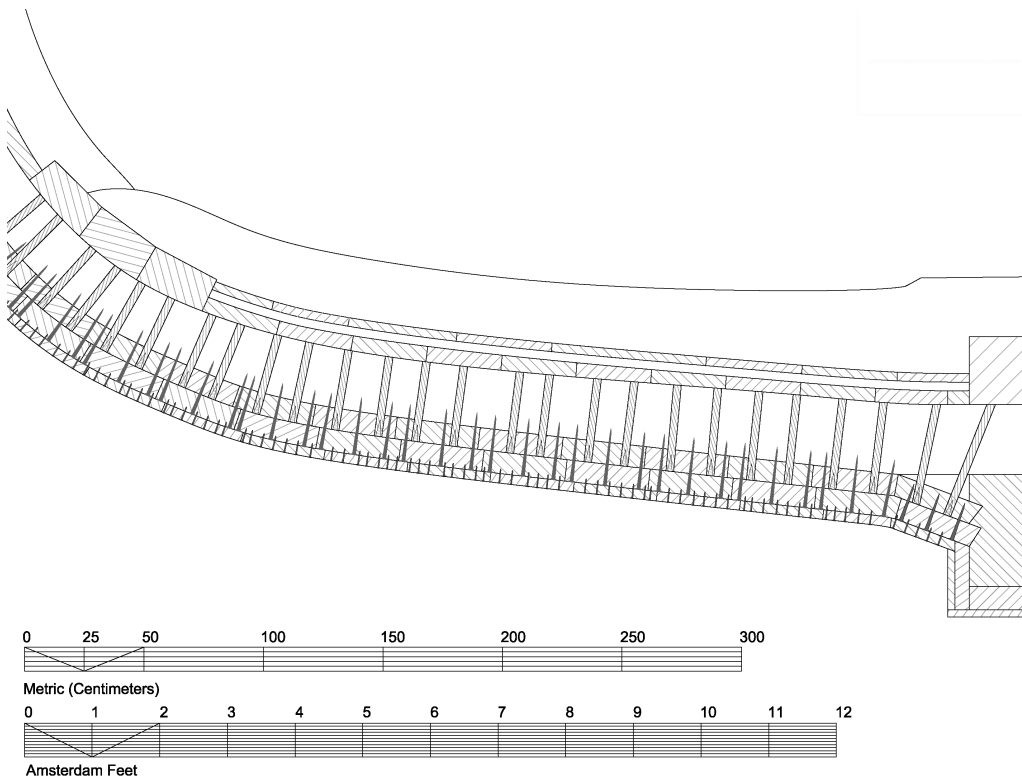
FIGURE 4-14.
Reconstruction plan
of bottom showing
assembly of the pine
sheathing, two layers
of hull planking, floor,
ceiling planking, cargo
floor planking, and
rider. Illustration by
author.

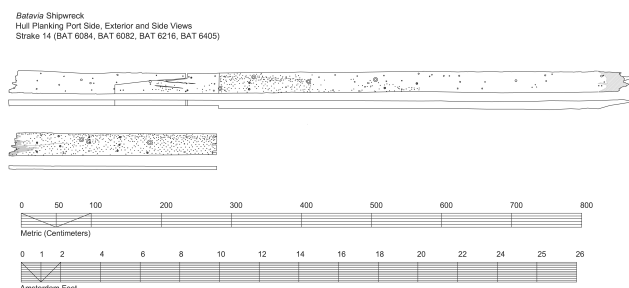
FIGURE 4-15. Hull planking strake with flat scarf and vertical flat scarf. Illustration by author.

vertical flat scarf that turns into a single layer of planking (fig. 4-15). The interior end of this scarf comprises two timbers joined by a regular flat scarf. The maximum thickness of strake 14 is 12.5 cm.

At first glance, it seems that no scarfs are present in the aftermost section of the ship's planking above the double-planked strakes, but upon closer inspection, vertical scarfs are found in strakes 13 and 14 (see figs. 4-15 and 4-17). These scarfs are best seen from the inside of the hull planking, which is currently not easily accessible because it is mostly covered with frame timbers. These scarfs are used to join the planks of the single-planked strakes of *Batavia*'s surviving hull structure.

The planks of two strakes are thus scarfed together with vertical flat scarfs. Their foremost planks are scarfed onto the outboard surface of the aftermost plank (see figs. 4-15, 4-17, and 4-18). One such scarf is present in strake 13, though poorly preserved and no longer complete, and measures 1.456 m in length (see fig. 4-17). This particular scarf end also has a rectangular graving piece (discussed later). The second vertical flat scarf is

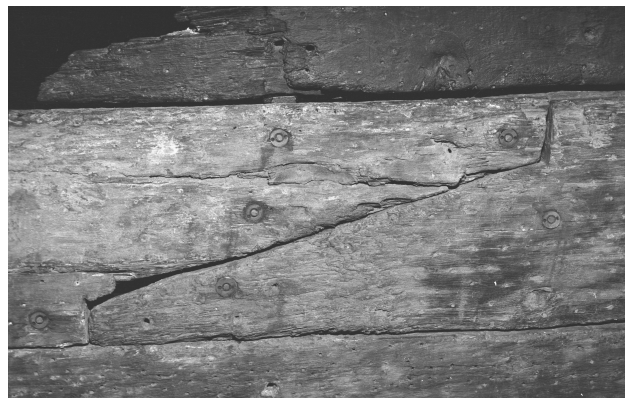
FIGURE 4-16. Flat scarf in planking strake 12, exterior of outer layer of hull planking, BAT 6014 and BAT 6106. Photograph by Patrick Baker, Western Australian Museum (MA4864-34).

The planks of double-planked strakes 1–12 and the interior end of the vertical flat scarf in strake 14 are all joined with flat scarfs (fig. 4-16). In the foremost preserved area of *Batavia*'s hull seven flat scarfs are preserved in the inner layer of hull planking and five in the outer layer. The close proximity of these scarfs must have created a weakness in the ship's hull. The complete scarfs of the inner layer of hull planking vary in length from 81.80 cm (strake 11, aft) to 1.08 m (strake 10). Their nibs measure from 5.1 cm (strake 10) to 10.5 cm (strake 14) in width, with an average width of 7.6 cm. The scarfs in the outer layer of hull planking are slightly smaller and vary in length from 71 to 96.2 cm. The dimensions of their nibs are similar to those of the inner layer of hull planking, measuring from 5.1 to 10.2 cm, with an average width of 7 cm.

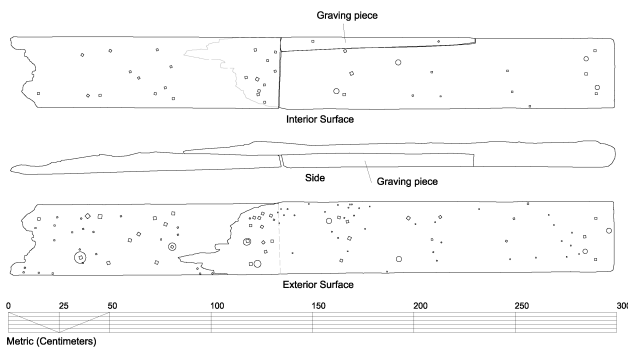
FIGURE 4-17. Hull planking strake 13 with vertical flat scarf, BAT 6397, BAT 6398, and BAT 6404. Illustration by author.

ing. It was secured in place with two iron nails and measures 96.1 cm in length, 7.1 cm in width, and 6.7 cm in thickness (see fig. 4-17).

In addition to goat hair, a mosslike material was found between the ends of a vertical flat scarf of hull plank BAT 6404, the aftermost end of strake 13 (approximately 80 cm forward of the transom). Most of the original overlying exterior end of this scarf had disintegrated on the seabed, exposing on the exterior face of the inner scarf what could have been moss as luting or coating in between the two scarf ends. The material was not sampled before conservation for species identification. Unfortunately, it was not preserved during the timber’s conservation treatment so is no longer available for further investigation and analyses (see figs. 4-17 and 4-46).

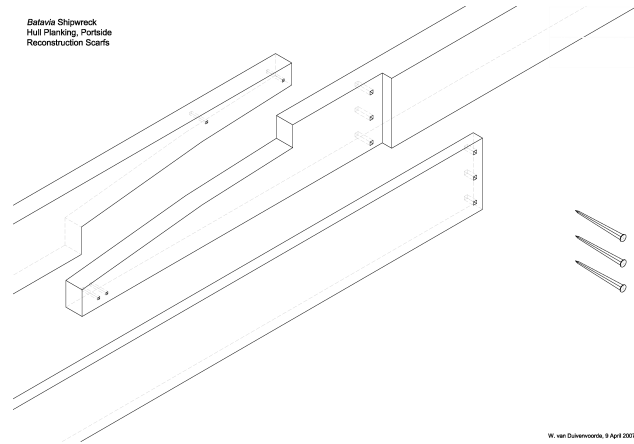
FIGURE 4-18. Isometric reconstruction of planking strake 14 with flat scarf and partial vertical flat scarf. Illustration by author.

situated in the fourteenth strake, from which only a vertical seam is visible at the exterior of the ship's hull. The overlying forward part is fastened to the underlying scarf end with three iron nails (see fig. 4-18). This scarf measures 3 m in length. Vertical flat scarfs are typical for northwestern European shipbuilding and have been found on the archaeological remains of thirteenth- and fourteenth-century coglike vessels, such as NZ43, NZ42, and Q75. They are also visible on iconographic representations of cogs on city seals. The vertical flat scarfs of *Batavia*, however, are much larger and more sophisticated than those of the medieval coglike vessels, which generally varied between 20 and 31 cm in length.²⁹

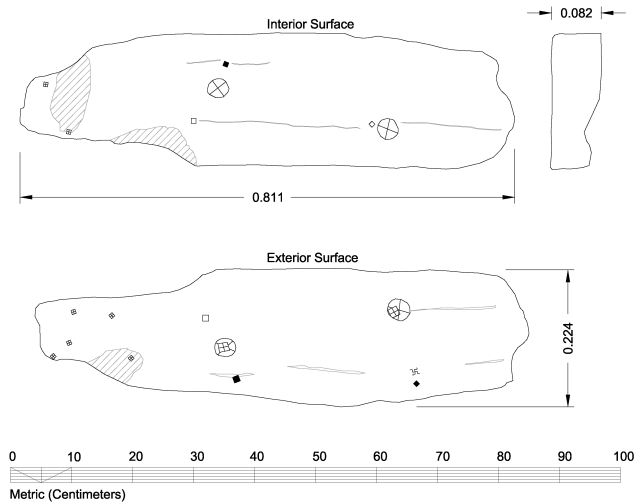
FIGURE 4-19.

Fragment of inner layer of hull planking showing pegged treenails, nail holes, and nail plugs, BAT 6375. Illustration by author.

Treenails that secured *Batavia*'s frames and planking in place are pegged with square hardwood pegs on their exterior ends (figs. 4-19 and 4-20). These pegs vary in width from 1.5 to 2 cm. In other shipwreck studies, authors have referred to pegged treenails as "wedged treenails," which is incorrect.³⁰ Treenail pegs are seated in the center of the treenails, are square in section, and taper to a point. Treenail wedges are rectangular, flat inserts that span the entire diameter of a treenail.³¹ In seventeenth-century Dutch VOC ships, treenail pegs are generally located at the exterior of the hull planking, whereas wedges are inserted on treenails on the interior of the hull timbers. Due to the poor preservation of *Batavia*'s frame timbers, in particular at the ship's forward end, no wedges have been found to date on the interior ends of the treenails.

Numerous nail plugs, also known as *spijkerpennen*,³⁴ have been found on both the interior and exterior surfaces of the inner layer of oak hull planking (see fig. 4-19, 4-23, and 4-24).³⁵ Nail plugs have been observed up to strake 10, BAT 6011, of the preserved hull planking. They may occur in strakes 11 and 12 as well, but it has not been possible to record nail plugs in these strakes as they are obscured by other timbers or surface damage from sulfur-reducing bacteria. A substantial number of hull planks do not have their original surfaces preserved due to this bacterial activity. The fastening holes left behind by the temporary cleats on the planking have a cross-sectional size of 5 mm, similar to that of the filling nails used to fasten the pine sheathing to the hull planking.

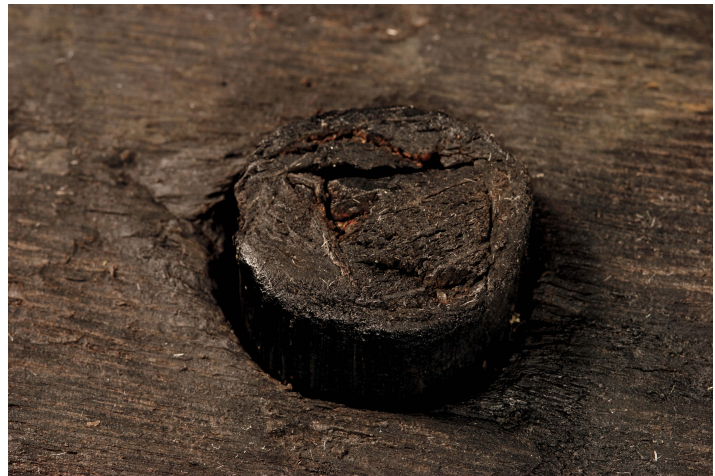
FIGURE 4-20.

Pegged treenail driven from the inner layer of hull planking, as seen on the exterior surface of plank BAT 6375. Photograph by Patrick Baker, Western Australian Museum.

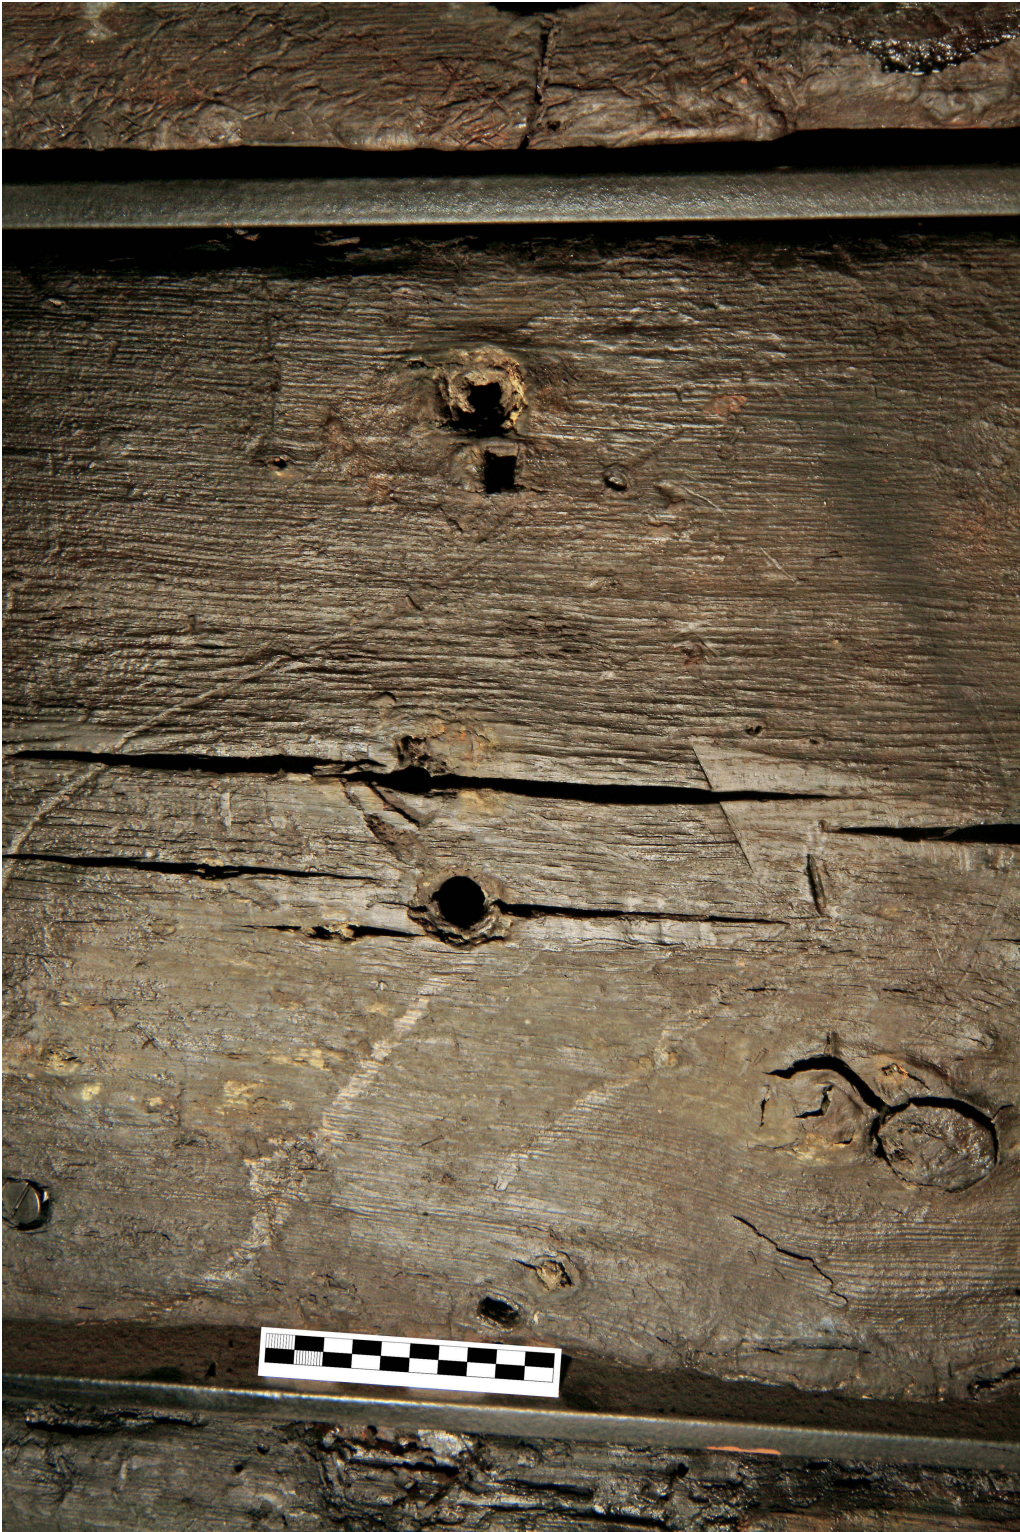
FIGURE 4-21. Nail holes on exterior of inner layer of hull planking directly forward of the transom. Nail head impressions with nail holes are from fasteners that fixed the inner layer to frames, whereas each nail hole next to them are from nails that fastened the outer layer of planking to the inner layer, BAT 6389. Photograph by Patrick Baker, Western Australian Museum.

The outer layer of hull planking was nailed to the inner layer, throughout the hull, with iron spikes, with an average of three spikes per plank at an interval of about 20 cm, or basically at each frame. Generally, the nails went through both layers of hull planking into the frames, so their original length must have exceeded 16 cm (see fig. 4-13). The nailing pattern of these spikes in the aftermost section of the hull is regular and may have been facilitated by the slight overlap in planking (fig. 4-21).³²

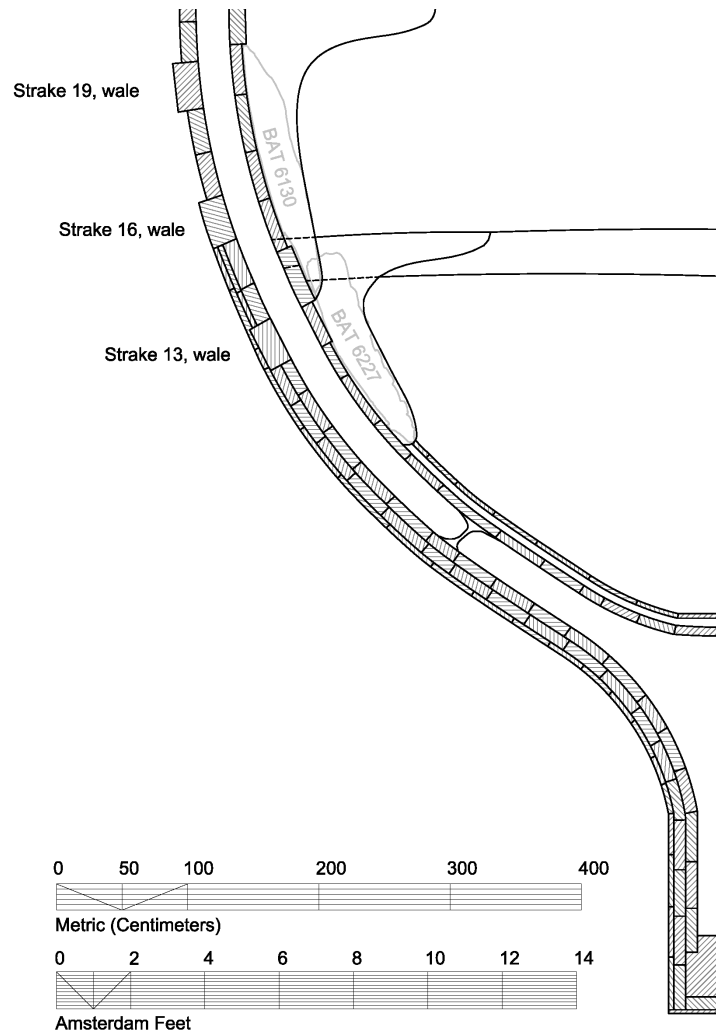
FIGURE 4-22.

Cross section of hull at frame C31, showing all layers of planking, frames, and hanging knees from lower and upper decks. Illustration by author.

Batavia's planking thickness changes from about 18 cm at its bottom to 12.5 cm on its sides (fig. 4-22). This change is not gradual but rather abrupt. Strake 14 is about 5.5 cm thinner than the thicker strakes below it. The ship's exterior curvature does not continue smoothly at the lower end of this particular strake but forms a straight interruption, a result of the change from a double-planked bottom to single-planked sides. Furthermore, on the exterior face of strake 14, two layers of pine sheathing were applied (discussed

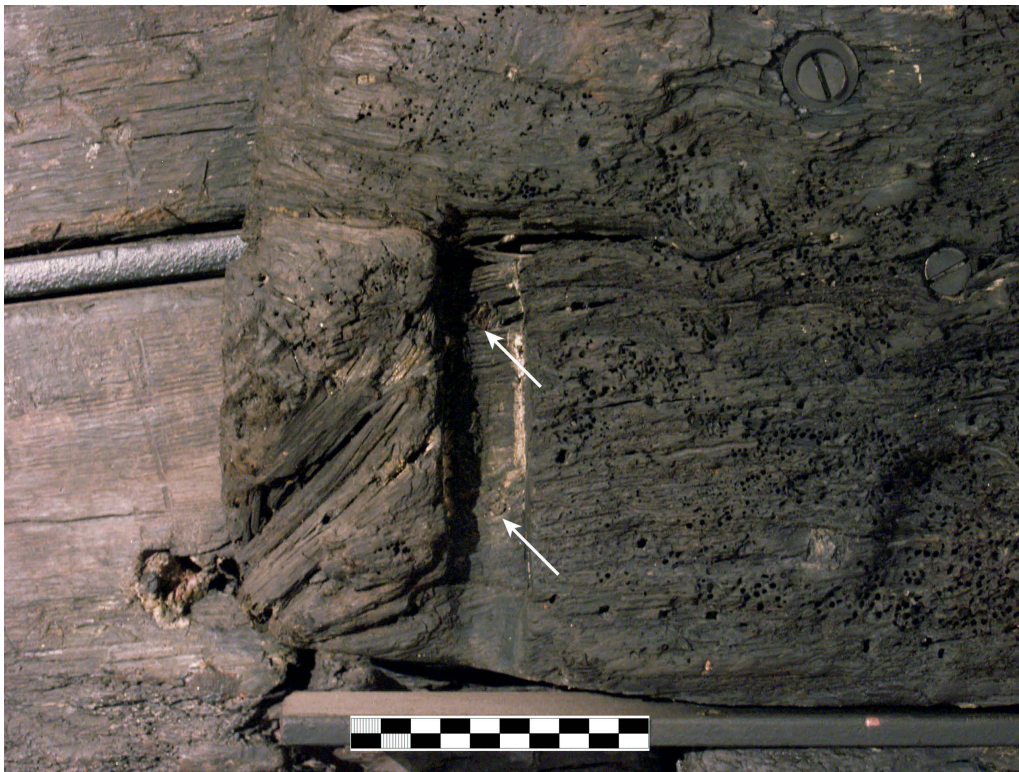
FIGURE 4-23. Two *spijkerpennen* (arrows) inside mortise for a temporary cleat on the exterior surface of outer layer of hull planking directly forward of the transom, BAT 6413, strake 4. Photograph by author.

Additionally, nail plugs have been observed in the outer layer of hull planking on the side of the ship that continues onto the transom (see fig. 4-23, BAT 6413). Here, temporary cleats were probably used to prevent the shoring poles from shifting during the ship's construction (see fig. 2-12).
